THE BRIDGE MANAGEMENT OF A TOLL MOTORWAY NETWORK RESULTS OF CURRENT DEVELOPMENTS AND IMPLEMENTATIONS

R. PÉREZ ARENAS & C. MILLÁN, Abertis Autopistas España

J.M. SIMÓN-TALERO, Torroja Ingeniería S.L.

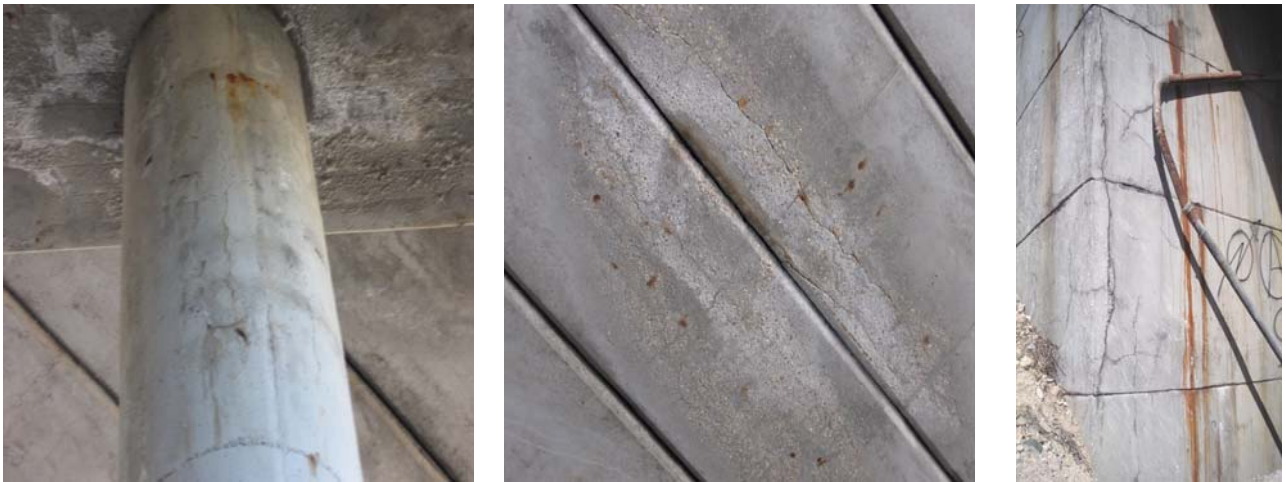
- There was no structure having indications of having a lack of the load capacity due to some damages on the structural elements.
- The 44% of all the structures have some cracks on structural elements, but the size of the cracks was usually small ($< 0,5$ mm), and so the bearing capacity was not affected.
- There were less than the 20% of all the structures having cracks due to corrosion; this is because the concrete use to be very compacted and the weather atmosphere was not very aggressive.

Figure 2 – Some crack son piers, decks and front walls

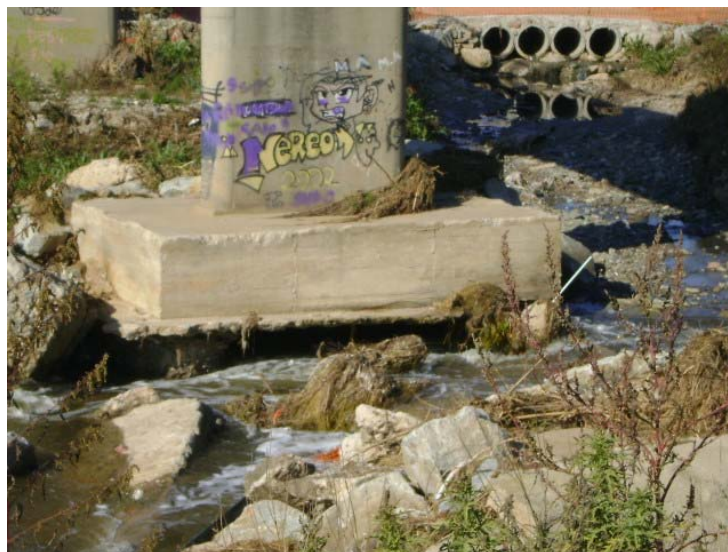
- There were settlements of the foundation, tilting of some walls or other damages due to scour problems on 23 structures.

Figure 3 – Scour effect on the foundation of a pier

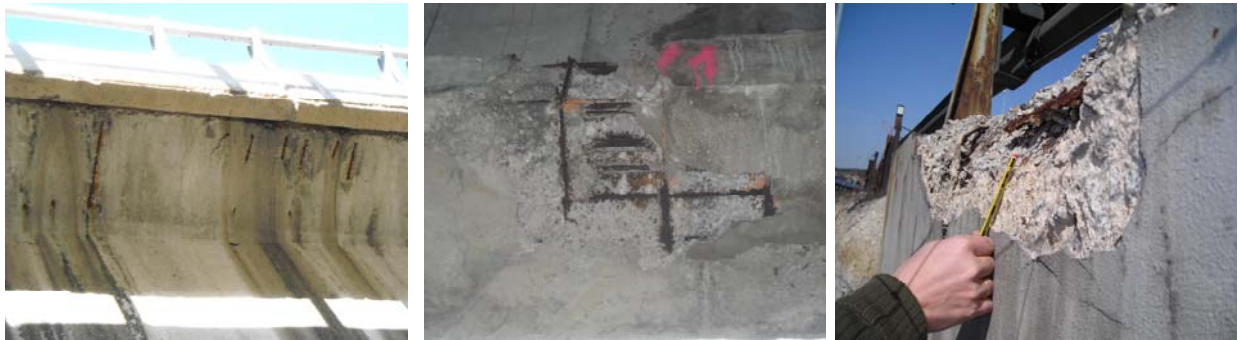
- There were 10000 m² of spalling on the concrete and some 26000 m² of reinforcing without cover and showing some indications of corrosion, but with no indications of structural affection.

Figure 4 – Loss of the cover and corroded reinforcing. Spalling of the concrete.

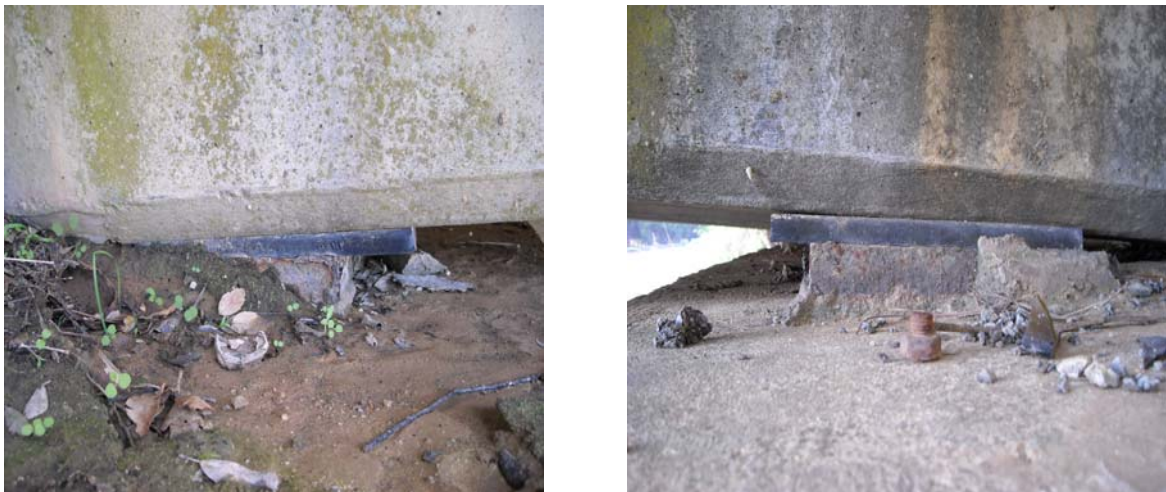
- There were some damages on the bearings of 263 bridges, that is nearly the 8% of the total structures.

Figure 5 – Blocked bearings o out of place

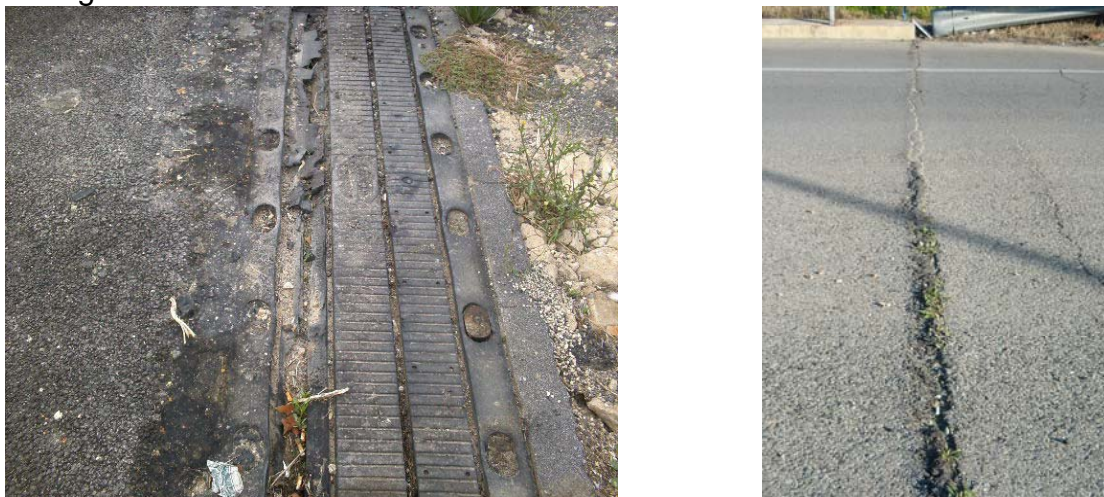
- The expansion joints of nearly 350 bridges, the 18% of all the bridges, were damaged.

Figure 6 – Damaged expansion joint . Non existing expansion joint

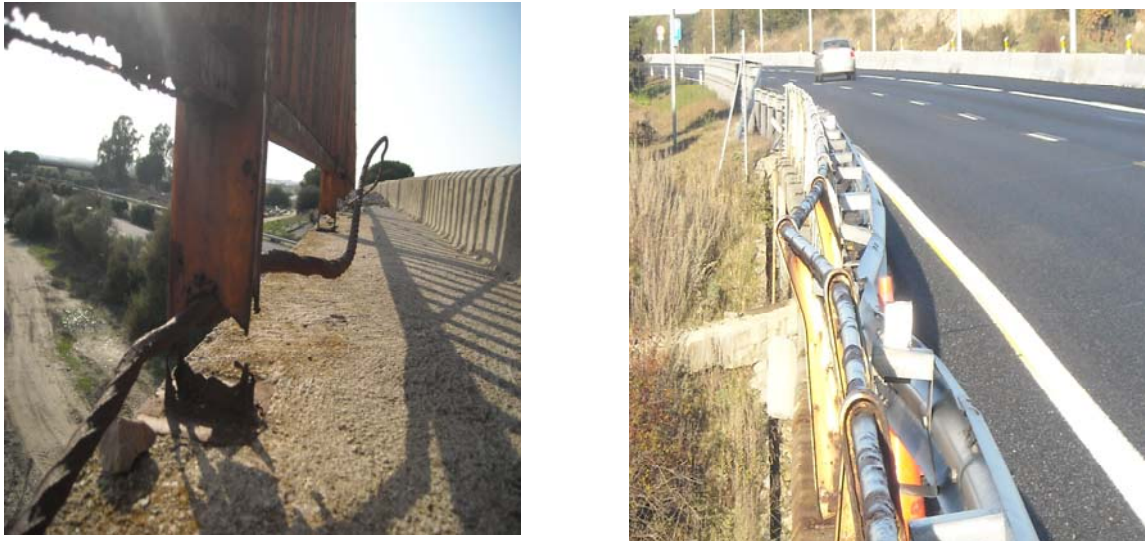
- The guardrails or the barriers of some 1300 structures were damaged, although nearly all of them will be repaired by the personnel in charge of the daily maintenance of the road.

Figure 7 – Damages on steel guardrails and barriers

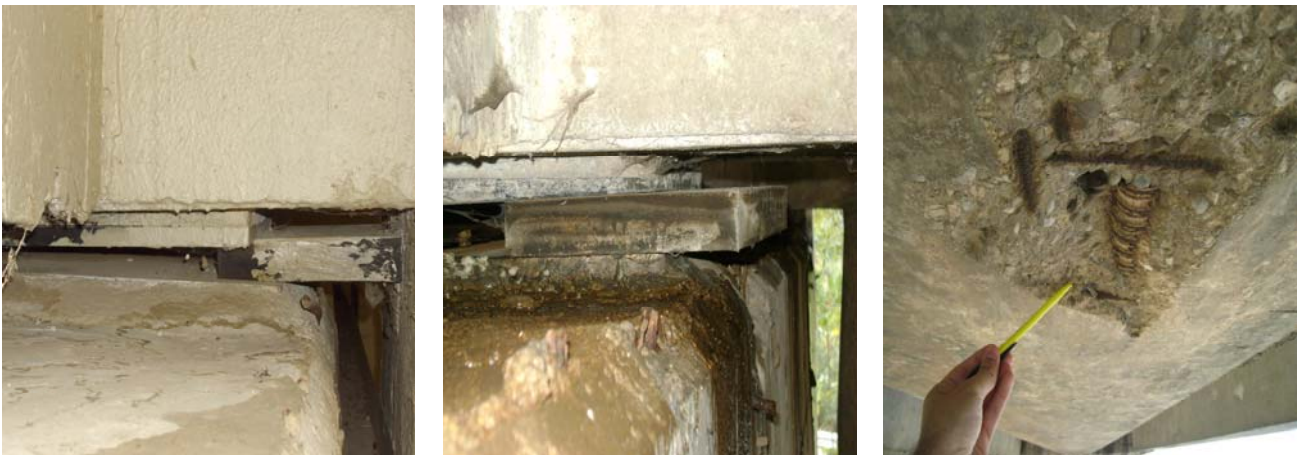
The results of the inspections made using special equipments showed some bearings out of place, the bad condition of the covering of some bearings or the lack of cover of a prestressed tendon; some cracks, not visible without using special accessing equipment, were also detected.

Figure 11 – An elastomeric bearing out of place, and a lack of cover of a prestressed tendon.

The average estimated cost for repairing the damages observed using special equipment were some 55000 euros per bridge, that is nearly 15 euros per m² of deck; this is a clear indication of the good condition of the inspected bridges.

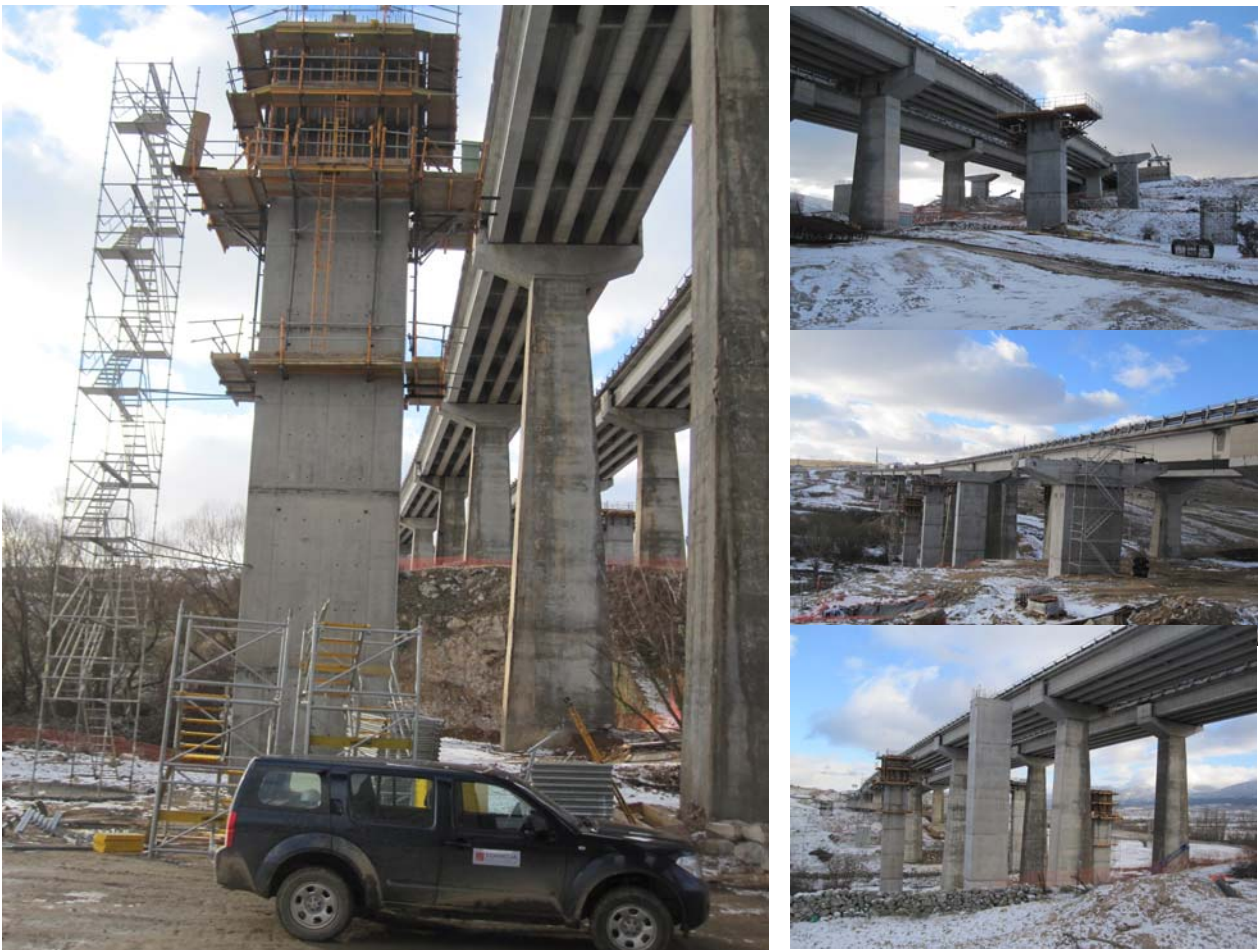
For example, now the enlargement of the platform, from 2 lanes to 3 lanes on each direction, of the section San Rafael-Villacastin (Segovia) of the toll motorway AP-6 is undergoing. Taking advantage of this situation, some repairing works, in addition to the enlargement and improving of some structures, are also being made such as the substitution of the bearings of the Viaduct of La Jarosa, the repairing works of some underpasses and the demolition of the deck of three existing bridges that were in very bad conditions due to the chloride attack.

Figure 12 – General views of the repairing works of some bridges of the AP-6

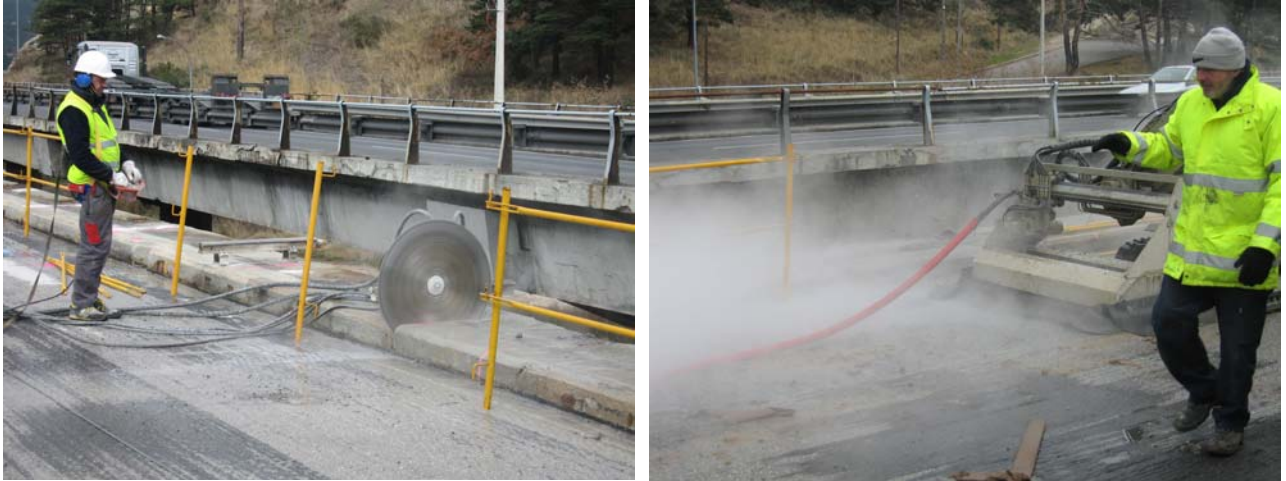
Moreover, the outer beams of the existing decks were severely damaged because of the use of chlorides in winter time, so it was proposed picking up the damaged beams and substituting them by some new ones. As it have been mentioned before, in some particular cases all the beams of the deck were substituted, because it was more effective changing all the beams, because of the poor condition of the beams.

Figura 13 –Repairing works of the top slab of the deck of the Viaduct of San Rafael (AP-6)

The Viaducts of San Rafael were seriously damaged and so it was proposed demolishing the compression slab of the deck and constructing a new one. Hydro demolition techniques have been used for demolishing the existing reinforced concrete slab of the deck. Special environmental measures have been followed while making such operations, particularly avoiding the dumping the waste of the demolition operations to the surroundings of the bridge.

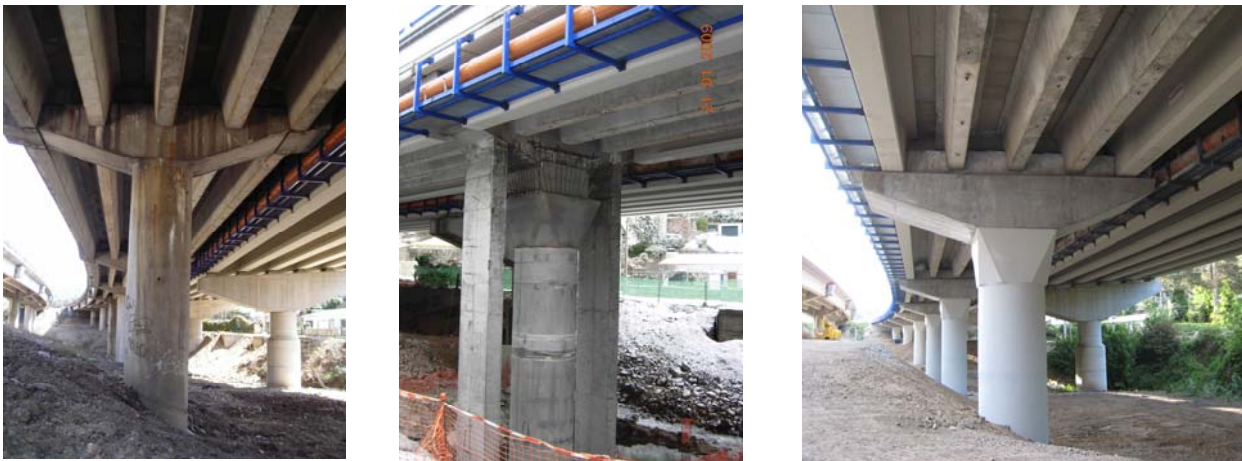
The piers and the piers cap were also repaired because they were also suffering Chemicals attacks due to the use of chlorides in winter time. The repairing works of the substructure have been made with no temporary diversion of the traffic over the deck.

Figure 14 –Repairing works of the piers of a bridge of the AP-6
