THE BRIDGE MANAGEMENT OF A TOLL MOTORWAY NETWORK RESULTS OF CURRENT DEVELOPMENTS AND IMPLEMENTATIONS

R. PÉREZ ARENAS & C. MILLÁN, Abertis Autopistas España

J.M. SIMÓN-TALERO, Torroja Ingeniería S.L.

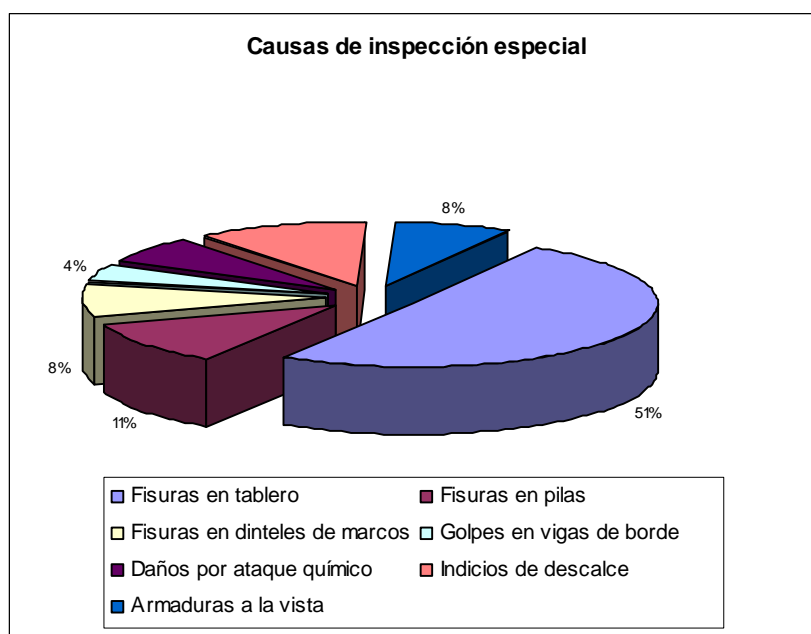
- 45 bridges have a lot of cracks due to bending moments on the decks.
- 10 bridges have lot of vertical cracks on the piers.
- 7 underpasses have a lot of horizontal cracks on the top slab
- The deck of 4 bridges has been hit by a over gauged traffic
- 6 bridges seems to have some kind of chemical attack on the concrete
- 10 structures were affected by some scour problems
- 7 structures have some other kind of concrete damages (spalling, corroded reinforcing,...)

Figure 8 – Special Inspections. Origin of the required detailed investigations.

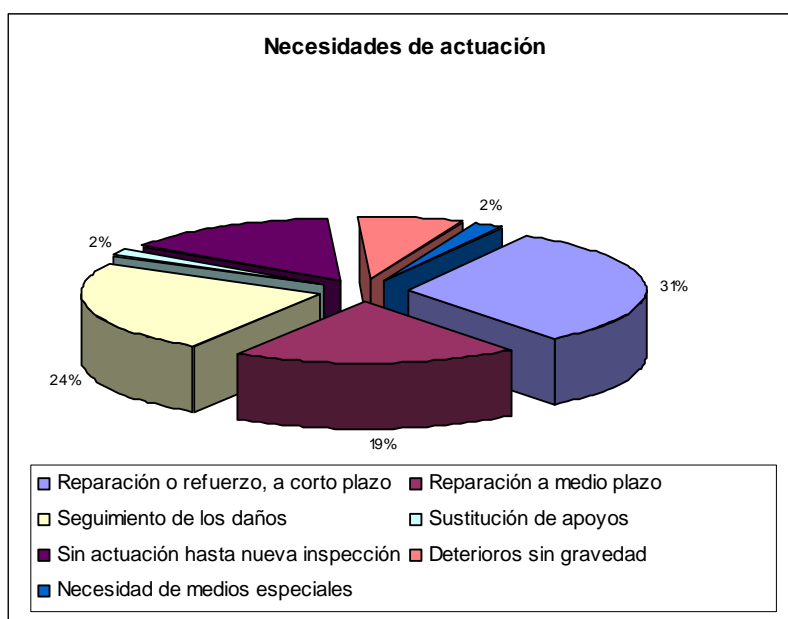
- 34 structures are recommended to be repaired in a short period of time
- 21 structures are recommended to be repaired in a not very long period of time
- 26 structures are recommended to be monitored in order to follow the evolution of the observed damages.
- The bearings of 2 structures are recommended to be substituted
- 16 structures were in good conditions and the observed damages were not dangerous.
- The observed damages of 8 structures were harmless.
- It was necessary to use special access equipment for investigating 2 structures, because the piers were very high.

Figure 9 – Results of the Special Inspections
